Our Ref: J178225 FI: 2
Your Ref: .
Date: 04/11/2019

MANAGEMENT ASBESTOS SURVEY

**FORMER LLOYDS BANK,
CAMP ROAD,
BORDON
GU35 0LH**

EAST HAMPSHIRE DISTRICT COUNCIL

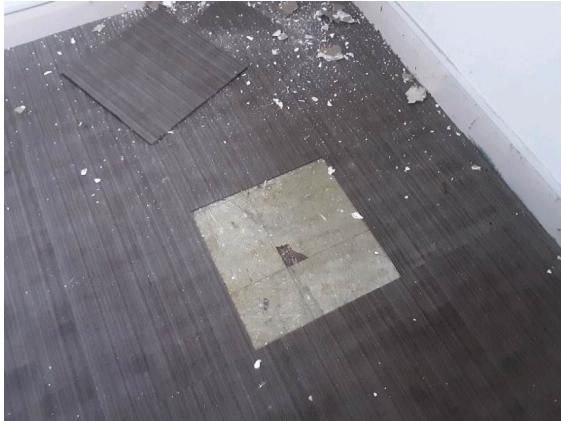
Vinyl floor tiles and adhesive beneath carpet. - Sample 2 - Asbestos Identified -
Recommendation - Manage

Sample No.	Sample Ref.	Location	Asbestos Detected	Asbestos Type
Sample 1	AA000759	Ground Floor Room 1, Putty to metal window frames.	No	
Sample 2	AA000760	Ground Floor Room 1, Vinyl floor tiles and adhesive beneath carpet.	Yes	Chrysotile

Sample No.	Location	Level of Identification	Extent	Accessibility	Product Type	Extent of Damage	Surface Treatment	Asbestos Type	Assessment Score	Recommended Action
Sample 2	Ground Floor Room 1, Vinyl floor tiles and adhesive beneath carpet.	Identified	12 m ²	Usually inaccessible or unlikely to be disturbed	Vinyl tile & adhesive	1 Low Damage	1 Completely Sealed	0 Chrysotile	1 Very Low	3 Management of ACMs (Manage)
Ref. Sample 2	Ground Floor Room 2, Vinyl floor tiles and adhesive beneath carpet.	Strongly Presumed	12 m ²	Usually inaccessible or unlikely to be disturbed	Vinyl tile & adhesive	1 Low Damage	1 Completely Sealed	0 Chrysotile	1 Very Low	3 Management of ACMs (Manage)

Sample 2: Former Lloyds Bank. Ground Floor. Room 1. Vinyl floor tiles and adhesive beneath carpet.

For the ACMs stated within the survey report requiring management it is recommended that their presence is noted, they are left in place and where appropriate that they are labelled. Additionally anyone who may damage the material in the course of their work is informed and abrading, drilling or cutting of the material should be avoided. The condition of the material should be reviewed on an annual or biannual basis.

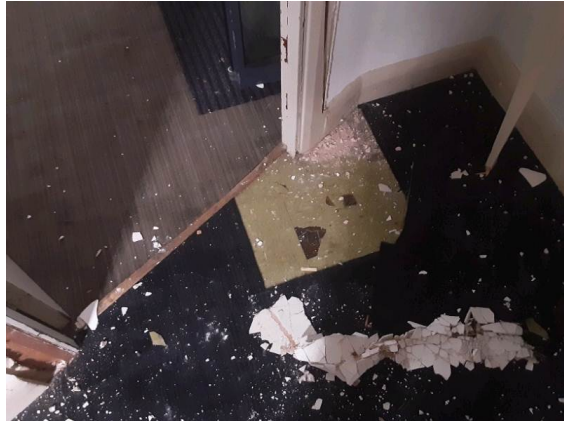
Vinyl floor tiles and adhesive beneath carpet. - Ref. Sample 2 - Asbestos Strongly Presumed -
Recommendation - Manage

Ref. Sample 2: Former Lloyds Bank. Ground Floor. Room 2. Vinyl floor tiles and adhesive beneath carpet.
