Our Ref: J175610 FI: 17
Your Ref: 200004040
Date: 03/10/2019

DEMOLITION ASBESTOS SURVEY
OF
LLOYDS BANK,
CAMP ROAD,
BORDEN,
HAMPSHIRE
GU35 0LH
ON BEHALF OF
EAST HAMPSHIRE DISTRICT COUNCIL

SECTION 1 - Executive Summary

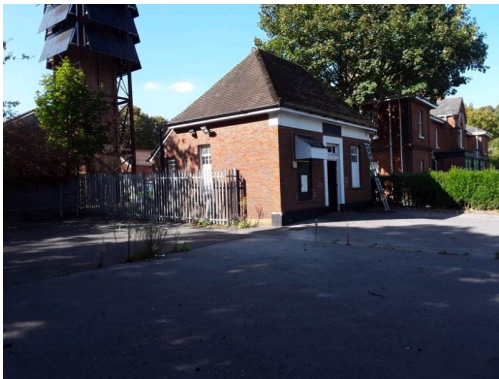
Externally the building is constructed of brick walls, clay roof tiles, wood soffits to front elevation, wood fascia boards and plastic rainwater goods.

Lloyds Bank, Camp Road, Borden,
Hampshire.

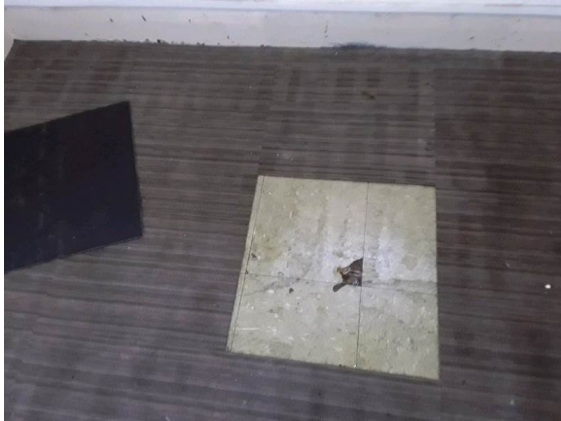
Sample 2: Lloyds Bank, Camp Road, Bordon, Hampshire.. Ground Floor. Area 1. Vinyl floor tiles and adhesive beneath carpet

SAMPLE NUMBER	SAMPLE DESCRIPTION	PRODUCT TYPE	ACTION REQUIRED
Sample 2	Ground Floor, Area 1, Vinyl floor tiles and adhesive beneath carpet	Vinyl tile & adhesive	Removal of non-licensed ACMs (Remove (non-licensed))
Visual 1	External, External, Insulation board soffits to rear elevation	Asbestos Insulating Board	Removal of licensed ACMs (Remove (licensed))

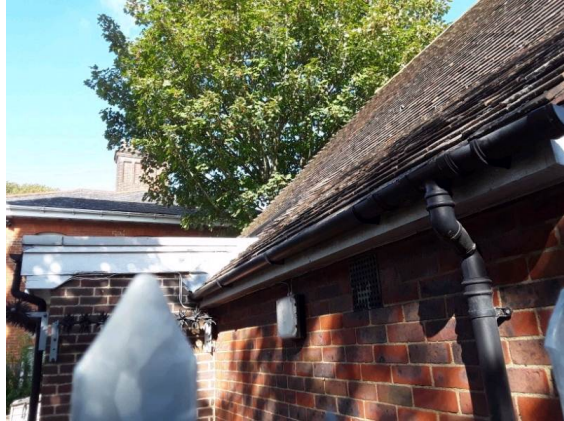
Visual 1: Lloyds Bank, Camp Road, Bordon, Hampshire.. External. External. Insulation board soffits to rear elevation
