MANAGEMENT ASBESTOS SURVEY
OF
BRICK BARN AT ECO STATION,
CAMP ROAD,
BORDON,
HAMPSHIRE
GU35 0LH
ON BEHALF OF
EAST HAMPSHIRE DISTRICT COUNCIL

SECTION 1 - Executive Summary

To carry out a management asbestos survey of the Brick Barn located at Eco Station, Camp Road, Bordon, Hampshire, GU35 0LH.

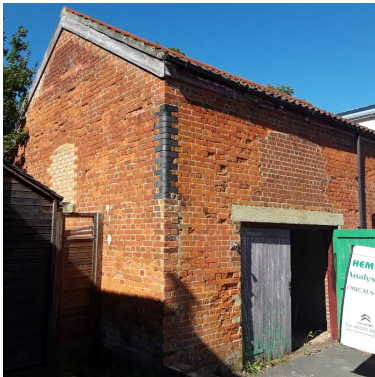
Brick Barn at Eco Station, Camp Road,
Bordon, Hampshire

Externally the property is constructed of brick walls, concrete roof tiles, wooden fascia boards, cement undercloaking to roof and plastic and metal rainwater goods.

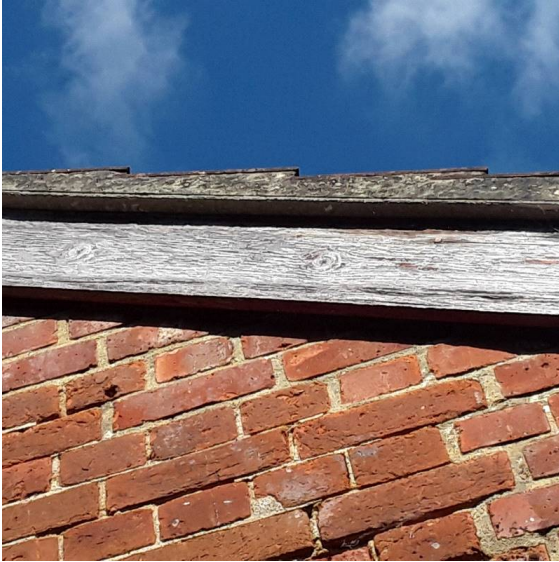
Visual 1: Brick Barn at Eco Station, Camp Road,
Bordon, Hampshire . External. External. Cement roof
undercloaking.

Cement roof undercloaking. Visual 1
Recommendation - Manage

Sample No.	Location	Level of Identification	Extent	Accessibility	Product Type	Extent of Damage	Surface Treatment	Asbestos Type	Assessment Score	Recommended Action
Visual 1	External External, Cement roof undercloaking.	Presumed	20 lm	Usually inaccessible or unlikely to be disturbed	Asbestos Cement	1 Low Damage	1 Surface Sealed	1 Chrysotile	1 Low 4	Management of ACMs (Manage)

For the ACMs stated within the survey report requiring management it is recommended that their presence is noted, they are left in place and where appropriate that they are labelled. Additionally anyone who may damage the material in the course of their work is informed and abrading, drilling or cutting of the material should be avoided. The condition of the material should be reviewed on an annual or biannual basis.

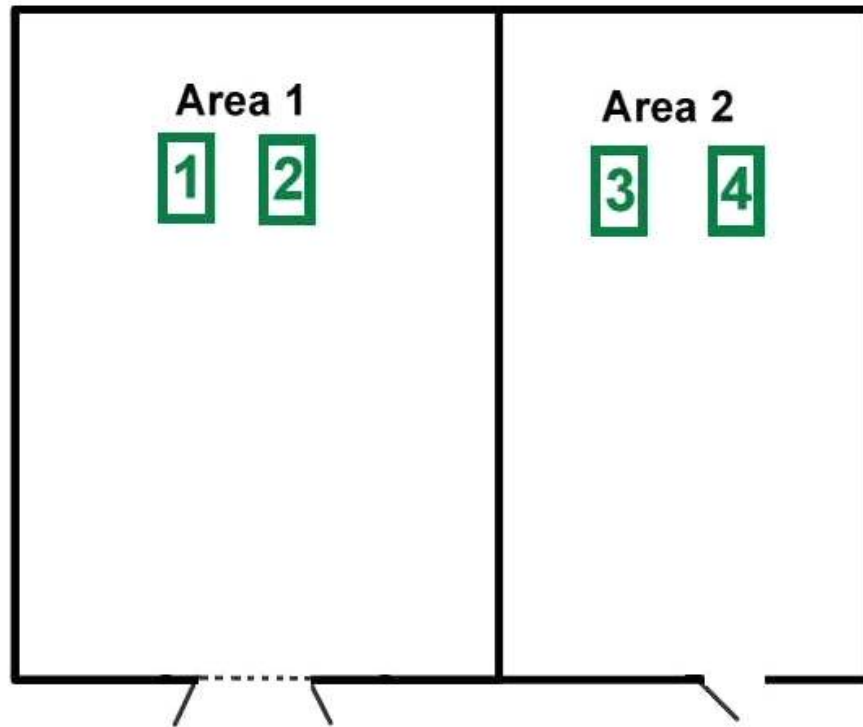
Ground Floor

Wooden floor, brick walls, wooden joists from original ceiling, bitumen felt to underside of roof and UPVC windows with solid sills.

Dust / debris to floor. - Sample 1 - No Asbestos Identified

Dust / debris to ledges. - Sample 2 - No Asbestos Identified

Concrete floor, brick walls and insulation board ceiling panels.

Dust / debris to floor. - Sample 3 - No Asbestos Identified

No access into live electrical boxes.

Insulation board ceiling panels. - Sample 4 - No Asbestos Identified
